# SOCIAL AND ENVIRONMENTAL PERCEPTION AND STATE OF PRESERVATION OF THE SPRINGS OF THE APODI-MOSSORÓ RIVER

**Vanessa Tainara da CUNHA** – Universidade Federal Rural do Semi-Árido (UFERSA)  
ORCID ID: <https://orcid.org/0000-0003-4037-400X>  
URL: <http://lattes.cnpq.br/3302251128340486>  
EMAIL: [vanessatainara62@gmail.com](mailto:vanessatainara62@gmail.com)

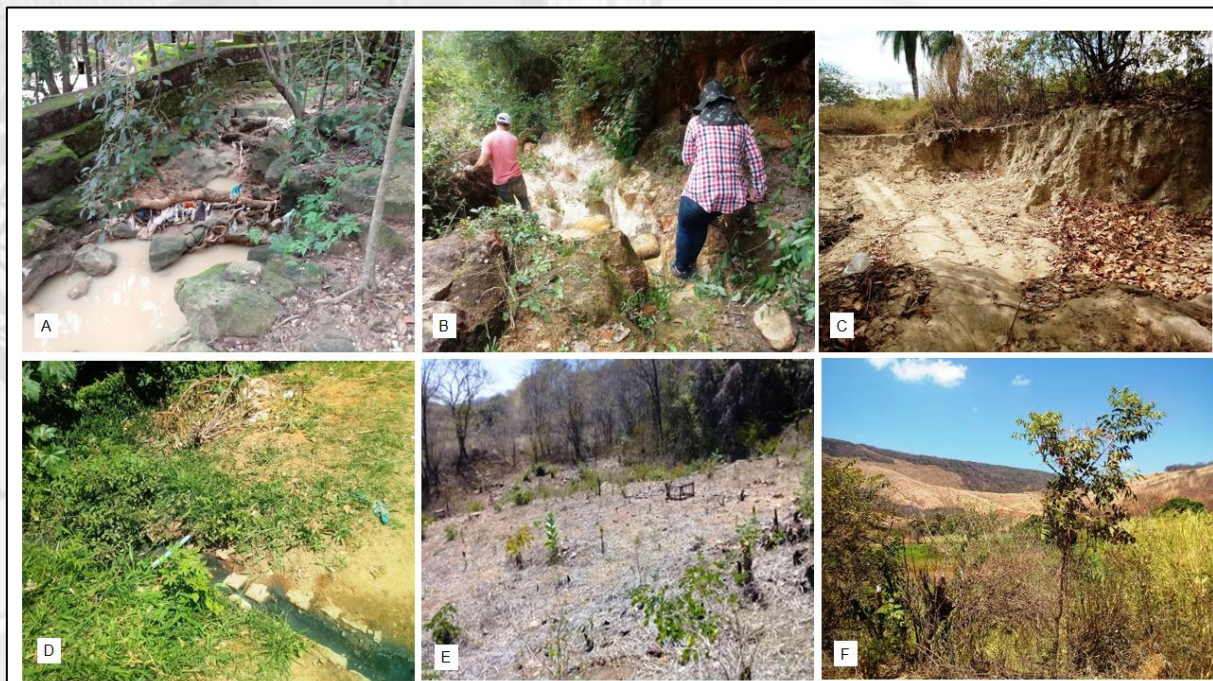
**Figure 02** – Environmental impacts present in the Apodi-Mossoró River Basin

By studying the springs in the Apodi-Mossoró River Basin, rural and urban area, through macroscopic analysis, it was possible to identify some environmental impacts (Figure 02). Figure 02A shows the environmental impacts present in *Nascente da Bica*, where it is possible to observe the presence of solid and liquid waste, since it is located near the urban area, and in periods of rain, the water flows down by gravity, carrying this waste from the city to the spring.

Near the *Nascente de Dona Rita*, located in Martins/RN (Figure 02B), within the radius of approximately 150m, it was possible to notice the presence of ravines, probably formed by the flow of water. However, Figure 02C and 02D shows clay extraction and the presence of open sewage, respectively. Figure 02E and 02F shows an area that was deforested and later burned and a deforested mountain chain, respectively. This practice is common in the city of São Miguel/RN.

Legend: A- Solid and liquid waste, Portalegre/RN; B- Soil loss (ravines), Martins/RN; C- Clay extraction, Luiz Gomes/RN; Open sewage, São Miguel/RN; E- Burned area, São Miguel/RN; F- Deforestation, Coronel João Pessoa/RN.
